EVALUATION OF MOUTH GUARD FOR AMALGAM LEACHING

A clear plastic mouth guard with gray discoloration on its back molars was submitted to the Georgia Tech Research Institute's Materials Analysis Center (GTRI MAC) for evaluation of possible dental amalgam leaching.

GTRI Lab Number 012414-001: Mouth Guard

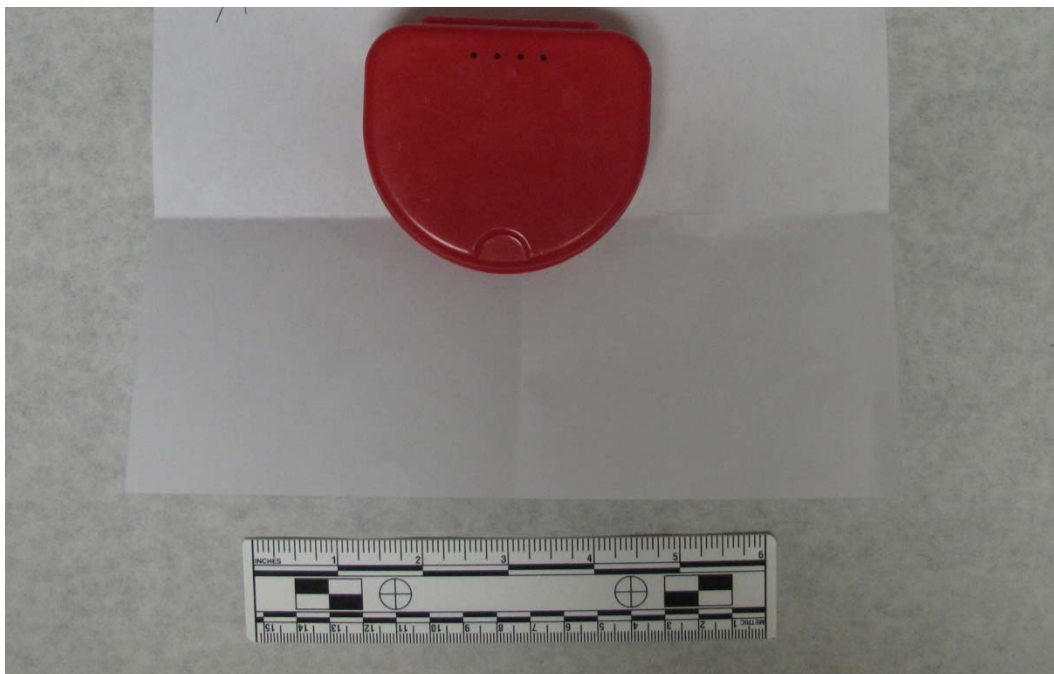
Figure 2: Log-in image of sample, case closed, as received

Figures 2 and 3 are log-in images of the mouth guard in the case. Figures 4-6 are images of the sectioned test pieces from the left and right molars and the incisor. Each image is labeled with specific test areas, which correspond to the labels in Tables 1-6. Tables 1, 3, and 5 present the averaged EDS elemental data for each test piece, and Tables 2, 4, and 6 present the elements of each test piece by concentration.

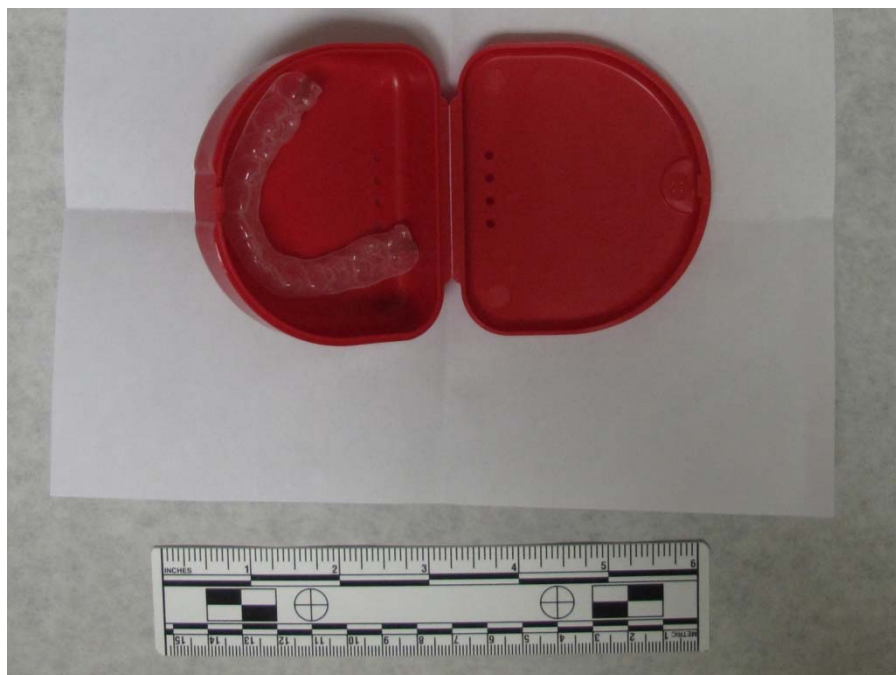
Figure 3: Log-in image of sample, case open, as received
